Technical Memorandum PMR-TM-68-4

ANTICORROSION SEALING CAPS FOR
MECHANICAL FASTENERS

W. L. MACKIE
Engineering Division

12 September 1968

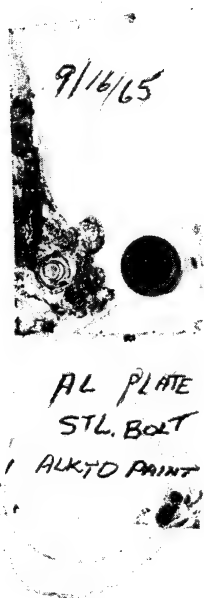
a. Before Exposure.

b. After Exposure.

Figure 4. Typical Salt Spray Test Specimens Before and After Exposure.

Two panels were assembled in a lap-joint configuration illustrated in figure 4. American Society for Testing and Materials (ASTM) Grade 5 bolts of various materials were used to fasten the lap joint. Table 1 describes the combinations of dissimilar metals and fasteners employed in each test specimen and lists the torque values used to tighten the joints.

A typical aluminum test specimen before and after exposure for 5,000 hours is shown in figure 4.

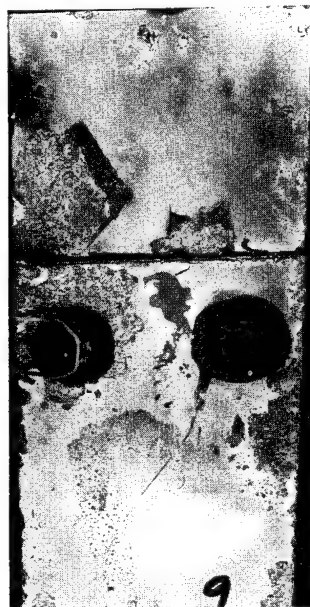
a. Test Specimen.

b. Cross Section of Protected Carbon Steel Bolt.

Figure 5. Magnesium Test Specimen With Carbon Steel Bolts
After 16-Month Weathering Test.
